S Y N T H E S I S   O N  
UNSTABILISED APPROACHES

The 5 Phases of the Approach Procedure	2
Incident with a 747-100 at Santo Domingo	4
Incident with a CRJ-100 at Montpellier	6
Accident involving a Fokker 50 at Luxembourg	8
Accident involving a CRJ-100 at Brest	10
Incident with an MD-83 at Nantes	12

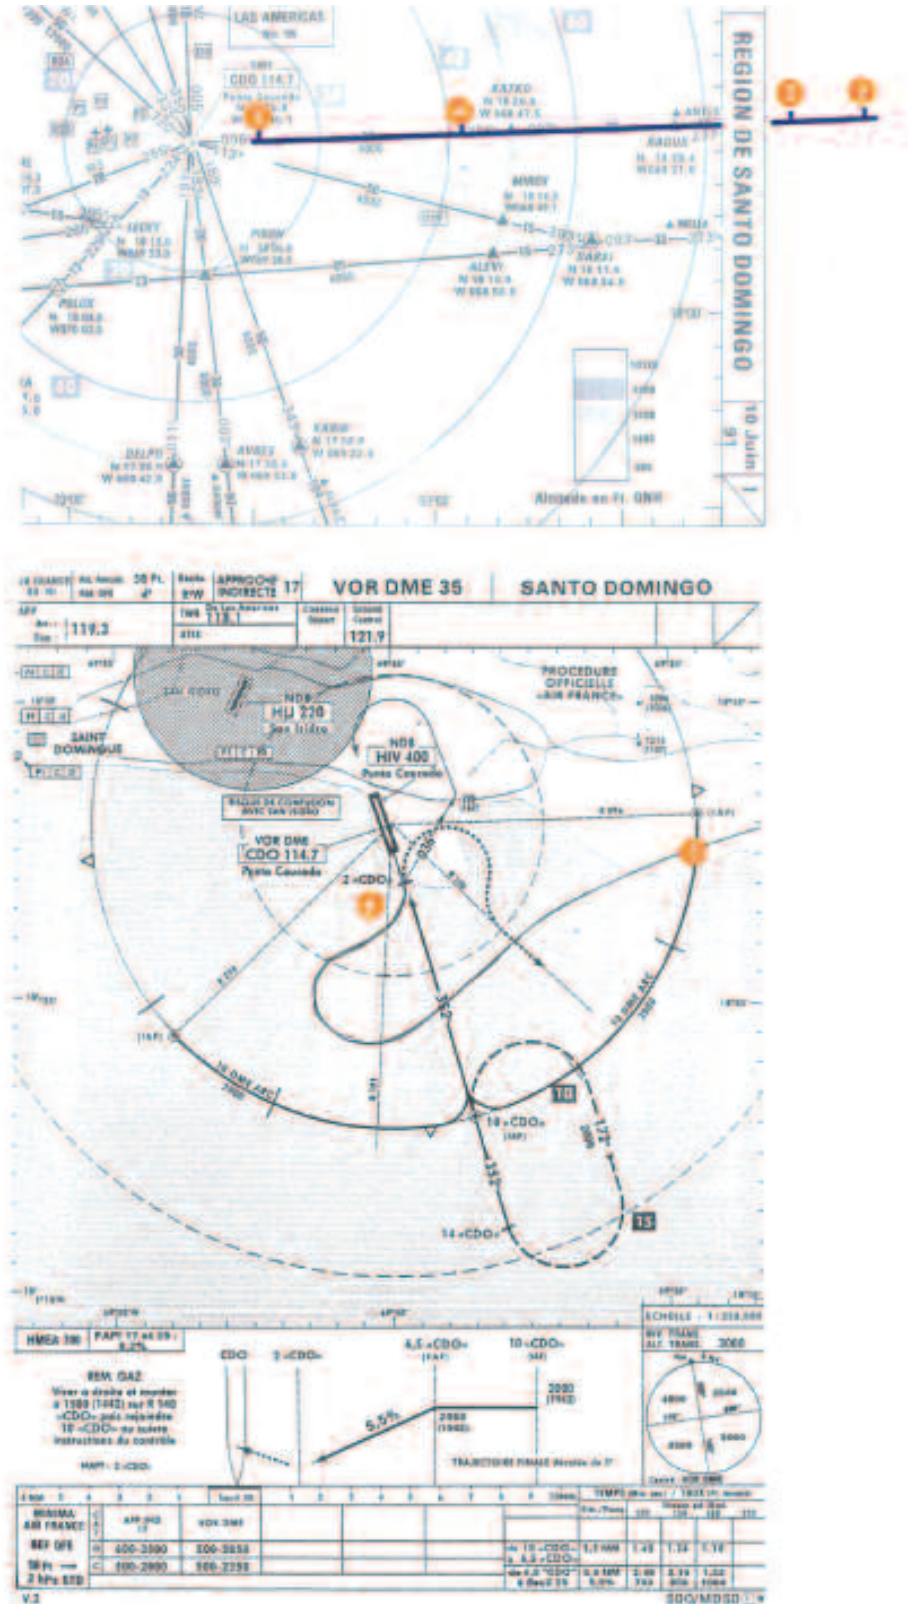
# INCIDENT INVOLVING A B747-100 AT SANTO DOMINGO, 2<sup>ND</sup> JULY 1993 AT 19:56 UTC

**Event:** runway overrun following a visual approach and landing during a rain shower.

The wind screen wipers are started by the PNF. At 163ft a brief GPWS alarm sounds. Near 80ft, the lateral visibility worsens. The flare is performed in a violent squall, mainly with the help of altitude callouts from the Flight Engineer. At touchdown the thrust reversers are operated and maximum braking applied. The crew have a sensation of aquaplaning. The aircraft leaves the runway and comes to a stop 150 metres beyond the end of the runway

The PF noted that the PAPI was locked below the approach flight path. Touchdown occurs at 147kts. The descending slope of the runway is more pronounced over the last 1200 metres. This information is not mentioned explicitly on the approach or aerodrome chart. 39 seconds expired between the wheels touching down and leaving the runway.

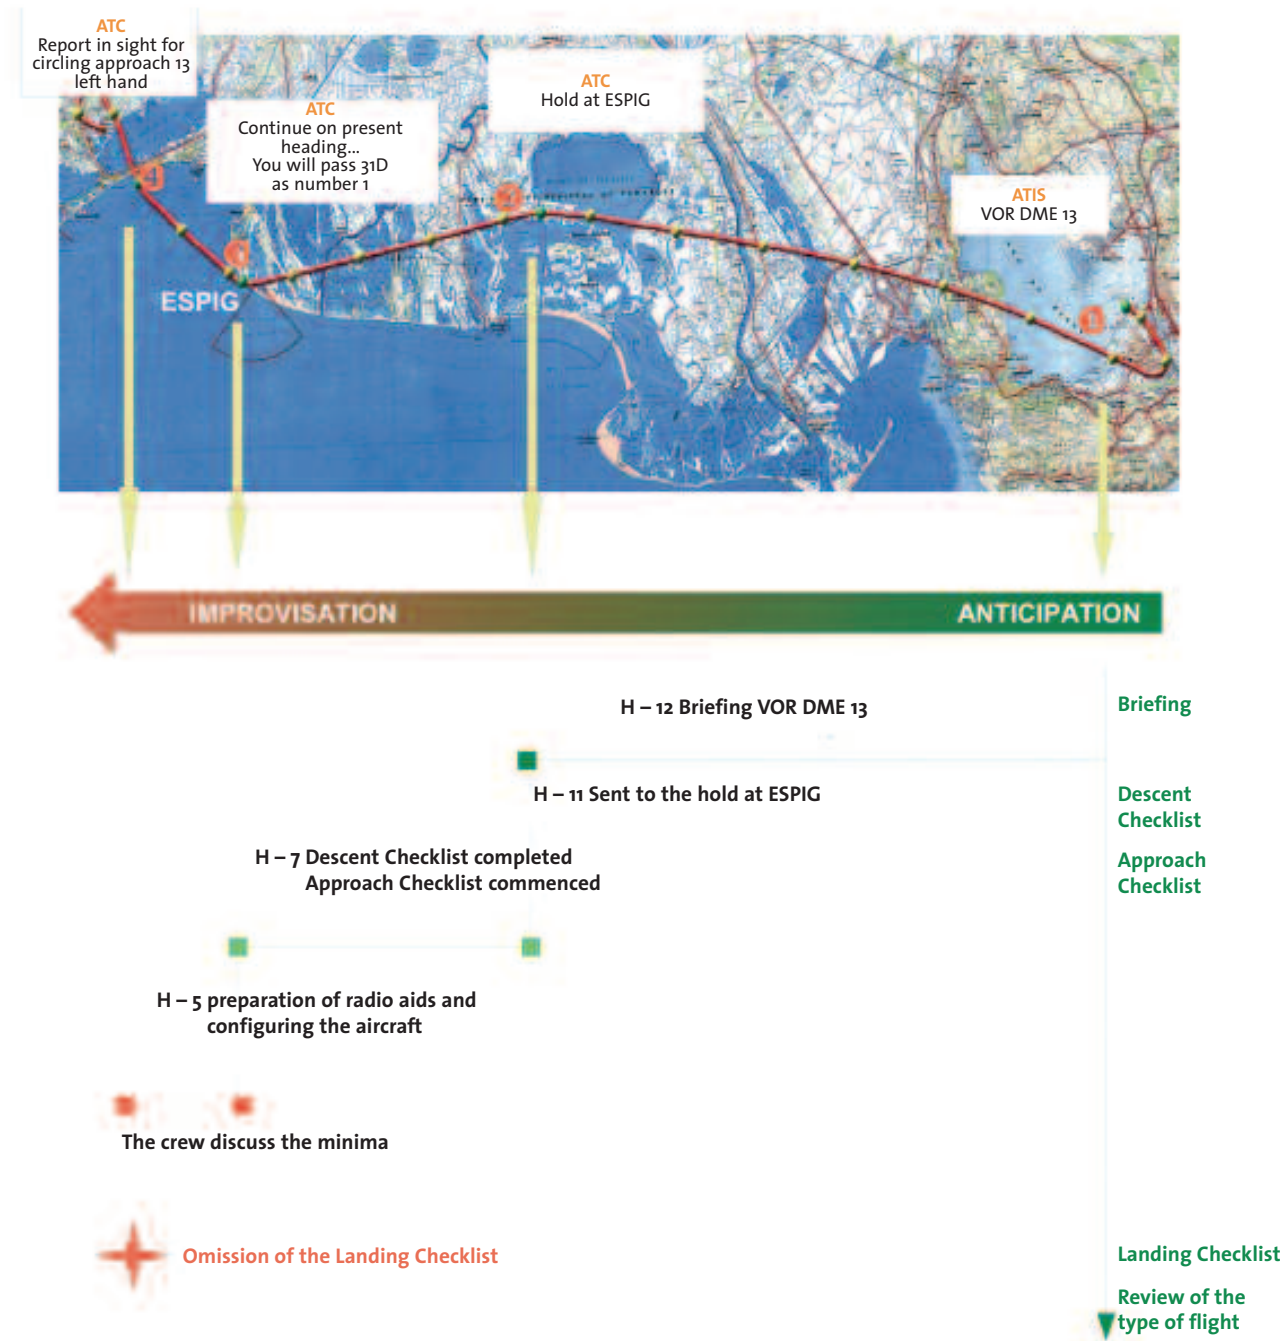
# INCIDENT INVOLVING A CRJ-100 AT MONTPELLIER FREJORGUES, 13<sup>TH</sup> JANUARY 1998 AT 23:03 LOCAL TIME

**Event:** runway overrun following an indirect circling approach.

The aircraft reaches 600ft downwind left-hand for runway 13 Left. The PNF gives the PF the necessary instructions to remain in visual contact with the runway. A windshear alarm during the last turn makes the crew select 30° flaps and increase speed by 5kts (i.e.  $V_{app}$  of 150kts). The aircraft experiences windshear for a second time. After the wheels touchdown, the Captain requests maximum thrust reverser. The PF asks the PNF to help him brake. The Captain asks the PF to switch off the nacelle anti-ice. The crew determine that selection of reverse thrust is not possible. The aircraft leaves the runway.

After having taken the joint decision to restrict the descent to 500ft, the crew start the Circling Approach at about 600 feet. The MDA for the Circling Approach is 780 feet.

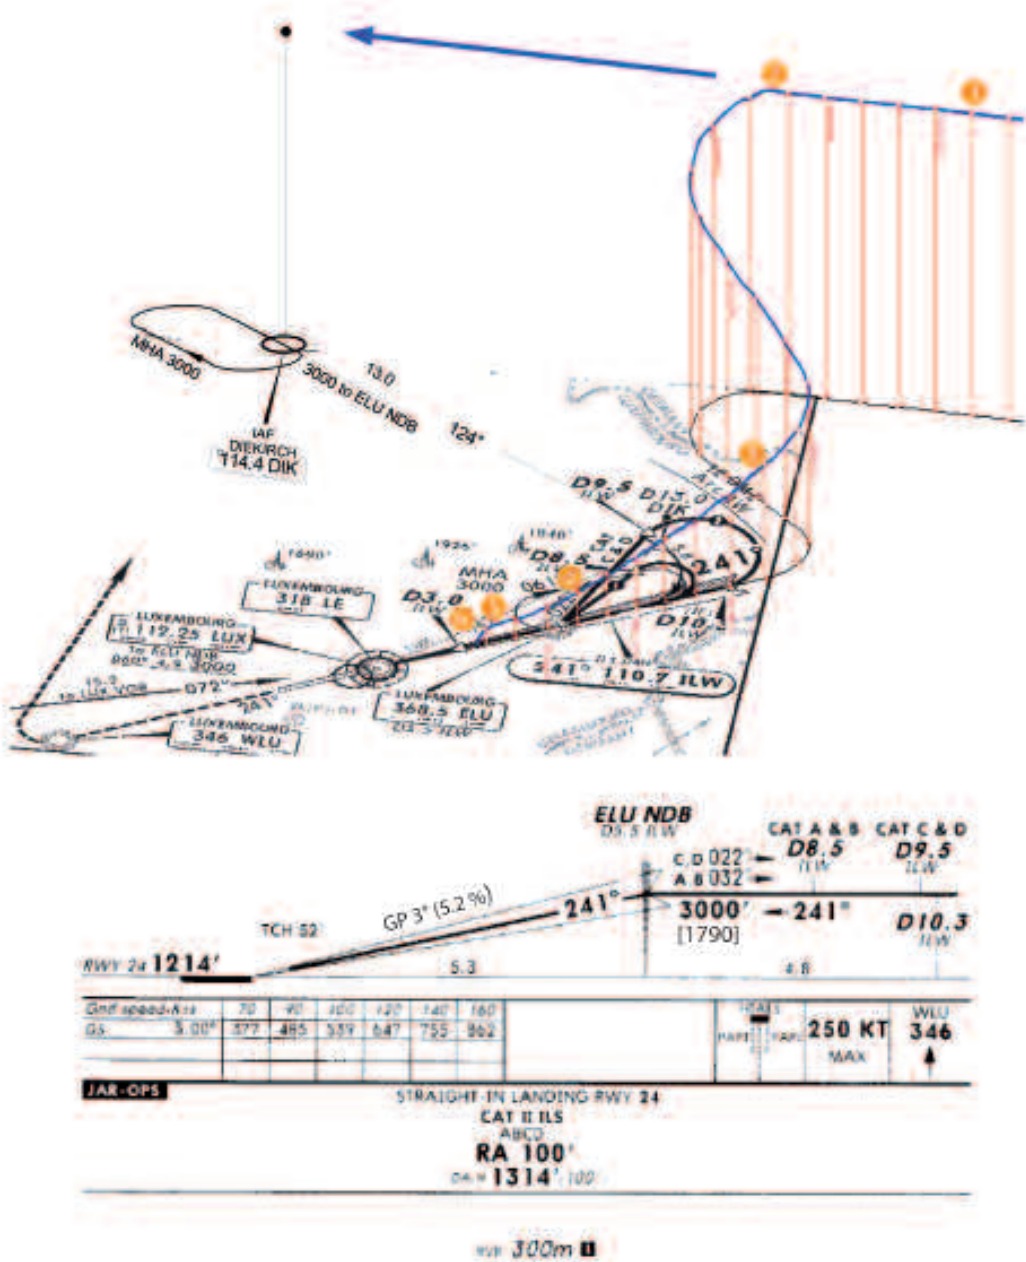
ACCIDENT TO A FOKKER 50 AT LUXEMBOURG,  
6<sup>TH</sup> NOVEMBER 2002 AT 09:05 LOCAL TIME

**Event:** Emergency landing after double engine failure on final approach.

- 6 H – 42s: Propellers enter Beta Mode**  
The captain retards the throttle levers, down to the flight-idle stop (the throttle levers therefore depend on the secondary safety system) and then puts the aircraft into the descent. The FO suggests lowering the flaps and then the gear. While the gear is lowering, the secondary safety device fails and the throttle levers retard further. The propellers enter Beta mode. The violent increase in drag makes the aircraft uncontrollable. The crew shut down both engines before carrying out an emergency landing.

A malfunction in the anti-skid box, caused by the gear deployment signal, removes the secondary safety system which in flight prevents the propellers entering the ground range from flight idle.  
The failure of the system locking the secondary stop-pin was not known to the pilot. It had been mentioned by the manufacturer but had not been widely communicated to the crews.

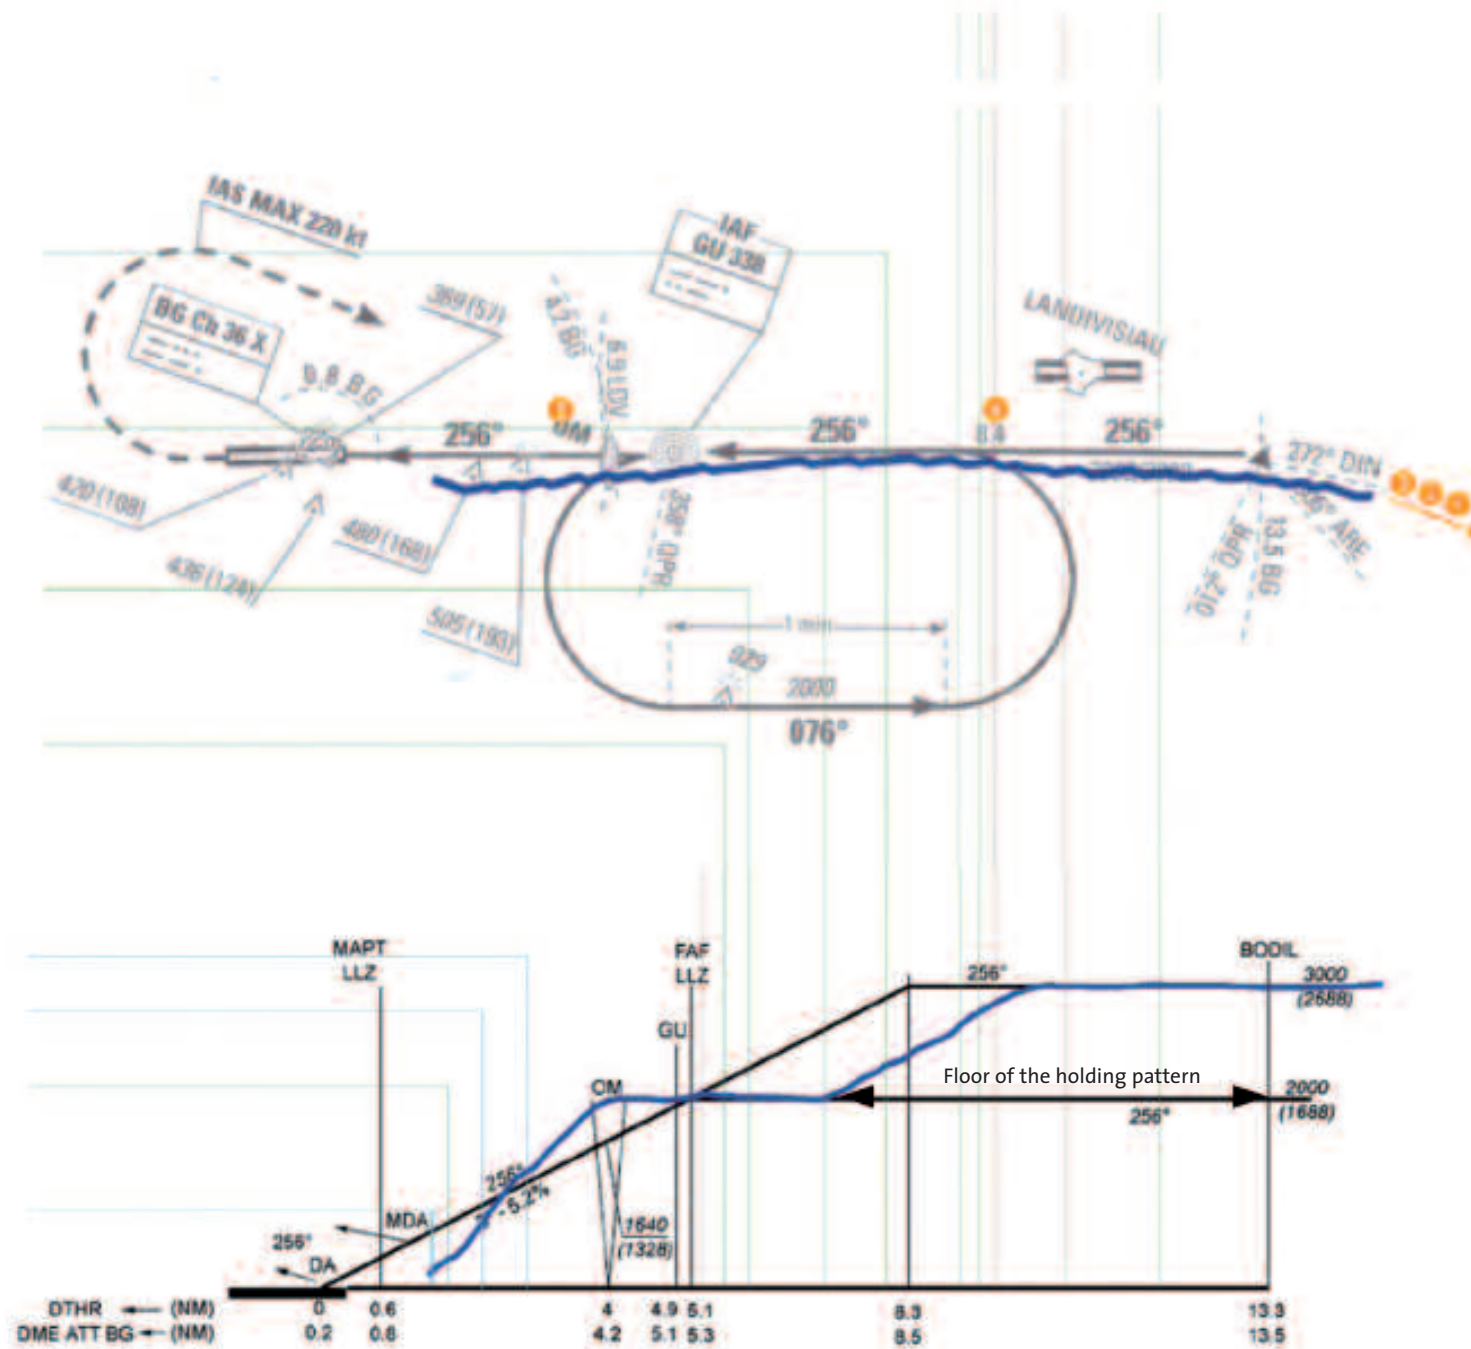
# ACCIDENT TO A CRJ-100 AT BREST, 22<sup>ND</sup> JUNE 2003 AT 23:51 LOCAL TIME

**Event:** collision with the ground after a go-around from the DA (DH).

The PF tries to engage Vertical Speed mode to get back on the glideslope from above. The aircraft continues to deviate and crosses the Outer Marker at 2000ft (vs. a correct crossing altitude of 1640ft) without any aural or visual alert occurring.

The aircraft arrives at DA without a callout. The PF calls out and initiates a go-around. The airspeed continues to decrease to 115kts while the pitch attitude decreases to -5° in four seconds. A second before impact the GPWS calls out PULL UP.
