Ice Crystal

Icing

A nearly undetectable weather hazard can knock out a jet engine.

BY MARK LACAGNINA

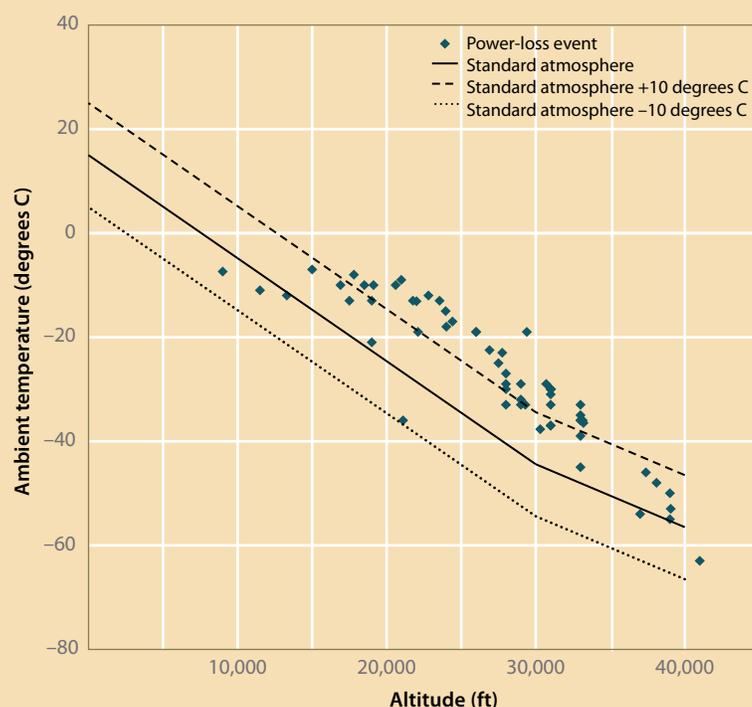
Figure 1

A report on a study of 46 power-loss events for which sufficient data were available revealed some common characteristics.¹ Most of the events occurred in summer, in relatively warm air above 20,000 ft and near convective weather (Figure 1). Many occurred in instrument meteorological conditions (IMC) with light to moderate turbulence. Several

Power-Loss Event Altitudes and Temperatures

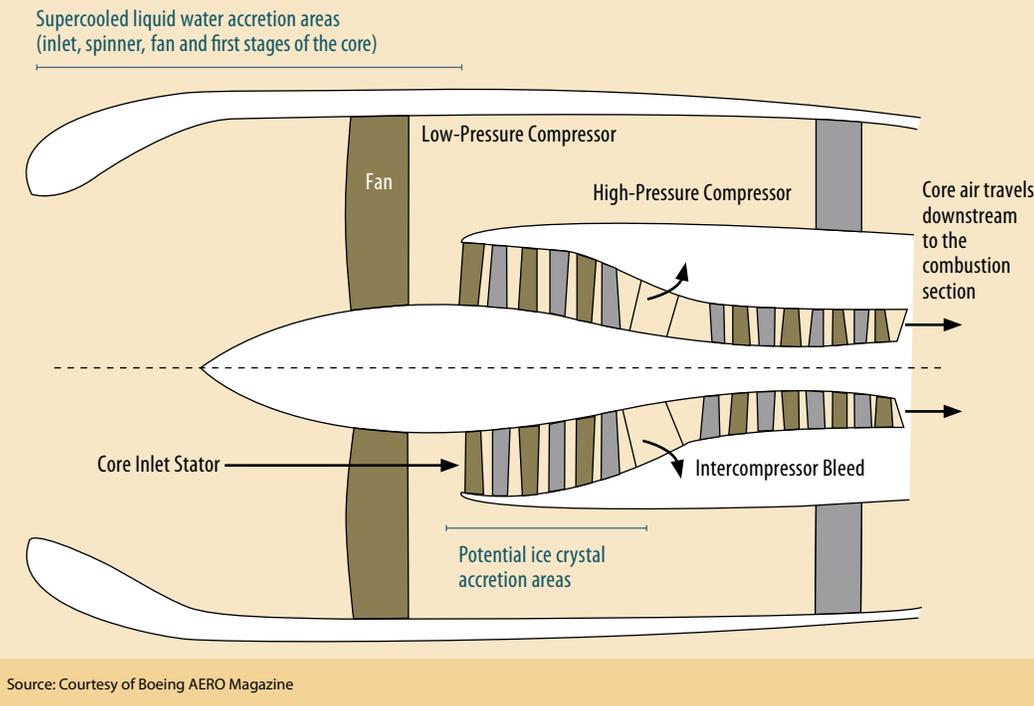
Figure 2

Ice crystals previously were thought to be harmless to airplanes because they would simply bounce off the airframe and engine surfaces, without accreting. Researchers now believe that ice crystals can partially melt, due to compression effects, as they pass through the engine fan section, enter the engine core and create a film of moisture on relatively warm surfaces, such as the

forward stator vanes (Figure 2, p. 14). The moisture traps additional ice crystals, and, eventually, the ice buildup is shed into the compressor, causing the engine to surge and stall, and possibly reaching the combustor, causing a flameout.

Ice Crystal Accretion Area
