S Y N T H E S I S   O N  
UNSTABILISED APPROACHES

The 5 Phases of the Approach Procedure	2
Incident with a 747-100 at Santo Domingo	4
Incident with a CRJ-100 at Montpellier	6
Accident involving a Fokker 50 at Luxembourg	8
Accident involving a CRJ-100 at Brest	10
Incident with an MD-83 at Nantes	12

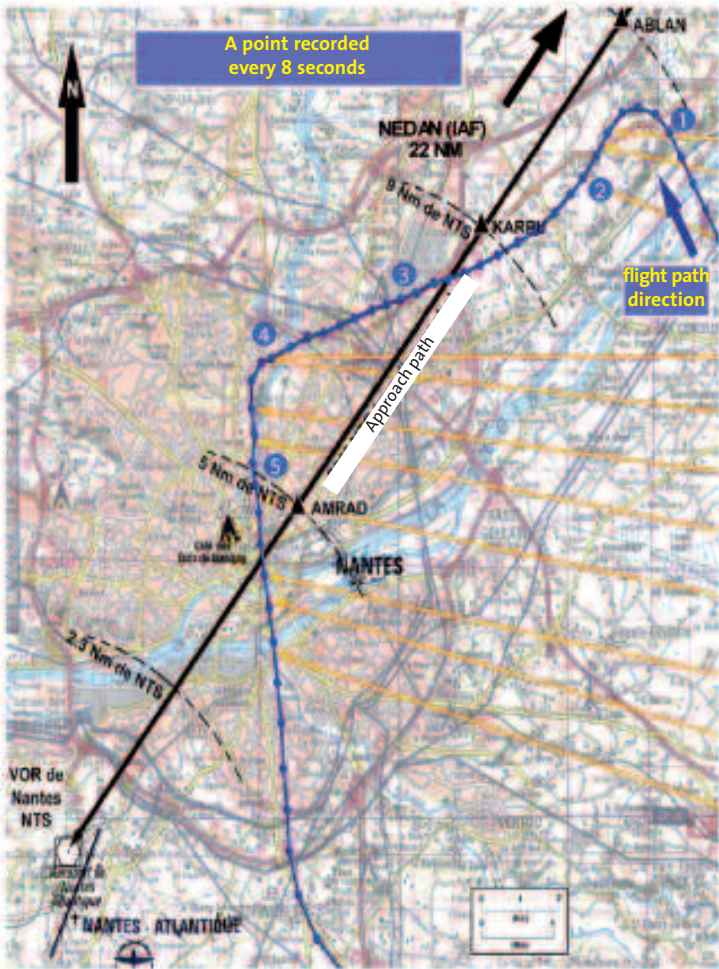
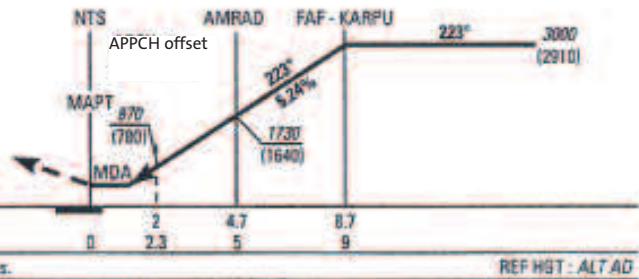
Missed Approach: at the MAP, climb straight ahead on NTS 223R. At 1000ft (910) climbing right turn to 3000ft (2910), intercept NTS 310R to rejoin the 15D DME arc right turn, unless instructed otherwise by ATC. Do not turn before the MAP.

Climb to 1000 (910) before accelerating in level flight.

C A T	VOR/DME OCH : 357		MVL		DME NTS							
	MDA (H)	RVR	MDA (H)	VIS	NM	8	7	6	5	4	3	2
A	450 (360)	2500	610 (520)	1500	ALT	2685	2365	2045	1730	1410	1090	775
B	470 (380)	2500	610 (520)	1600	(HGT)	(2505)	(2275)	(1955)	(1640)	(1320)	(1000)	(685)
C	500 (410)	3000	650 (560)	2400								
D	520 (430)	3000	650 (560)	3000
